## Hydro morphological assessment using the habitat survey method of Pandurucan River in San Jose, Occidental Mindoro

Michelle D. Enriquez<sup>1</sup>

<sup>1</sup> College of Engineering, Occidental Mindoro State College, San Jose, Occidental Mindoro, Philippines 5100

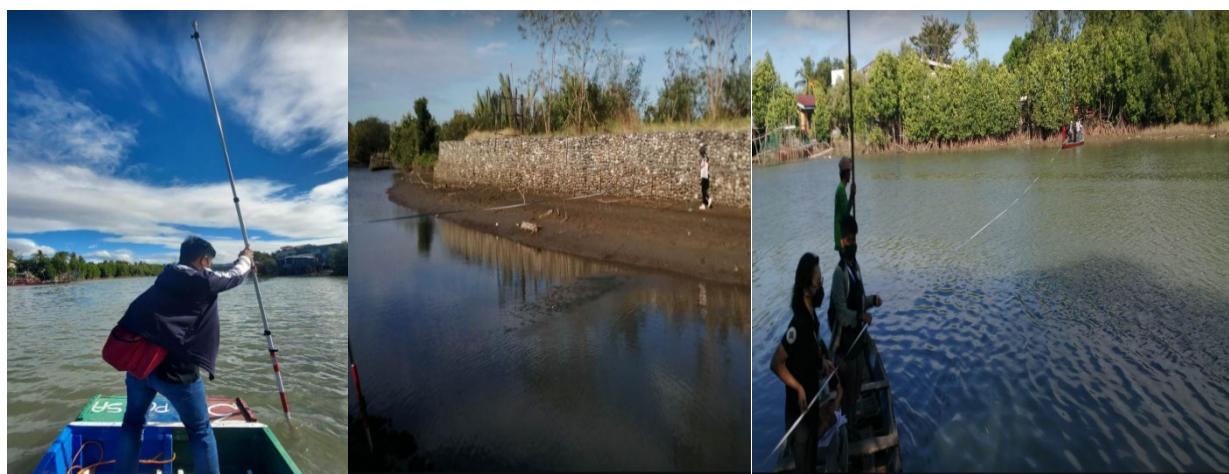
Image 2. Field survey for the depth and width of the river bank

The depth of the water was determined by the average values of depth measured using a range pole during the field survey. The exact spot-check coordinates were determined using a GPS device, while the elevations of the sites were measured from the mean sea level with the help of Google Earth and calibrated through the GPS device. The bank top width was measured on site [Image 2].

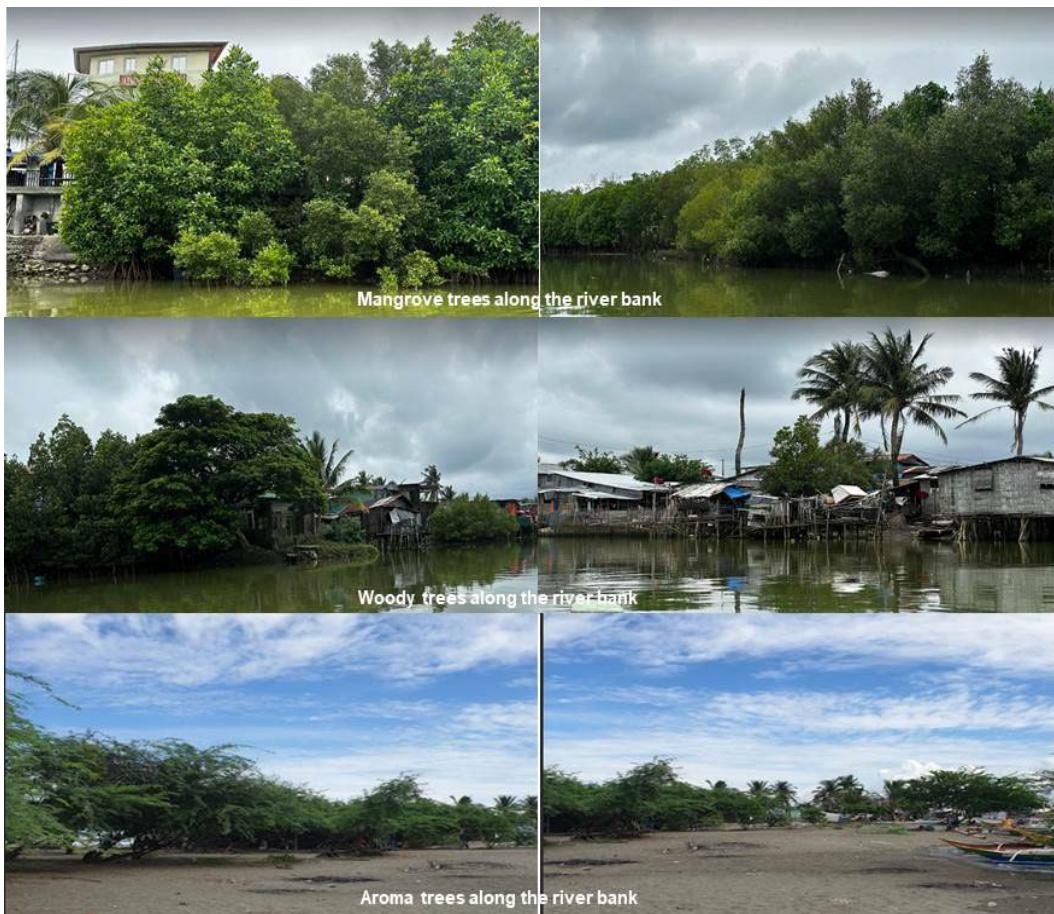
Image 5. Types of vegetation present in the study area.

Further, the channel vegetation type described the functional habitat provided for other living organisms in the river. Some of the features were categorized as free-floating from the presence of fallen leaves in Transect 1; amphibious from the mangrove trees arranged along the riverbank; submerged fine leaves from the long leafy plants observed; and the filamentous algae stacked on the stones and boulders along the riverbank [Image 5].

The field observation conducted in this study provided an in-depth description of the existing vegetation along the selected stretch of the Pandurucan River. The results showed varying vegetation features classified as bare, uniform, simple, and complex. Bare features were observed along portions of the riverbank lacking any type of vegetation. The uniform features were characterized by the presence of mangrove and aroma trees arranged in linear formations. The simple features referred to sections of the riverbank with a single type of tree, while complex features represented areas containing a diversity of vegetation types.
